US Army Corps  
of Engineers®  
Engineer Research and  
Development Center

## **Periodic Inspections of Hilo, Kahului, Laupahoehoe, and Nawiliwili Breakwaters, Hawaii**

Armor Unit Monitoring for Period 2001-2005

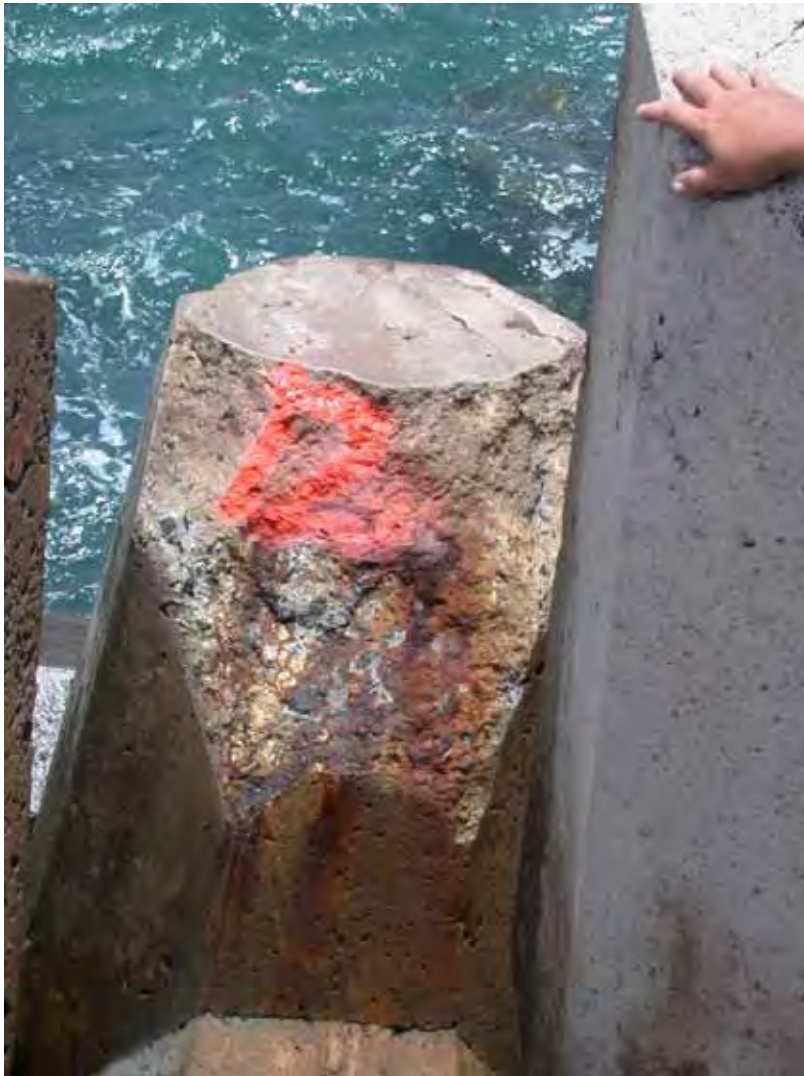
Figure B21. Damage location 26, sta 28+04, ocean side, rib #30, dolosse with tip chip.

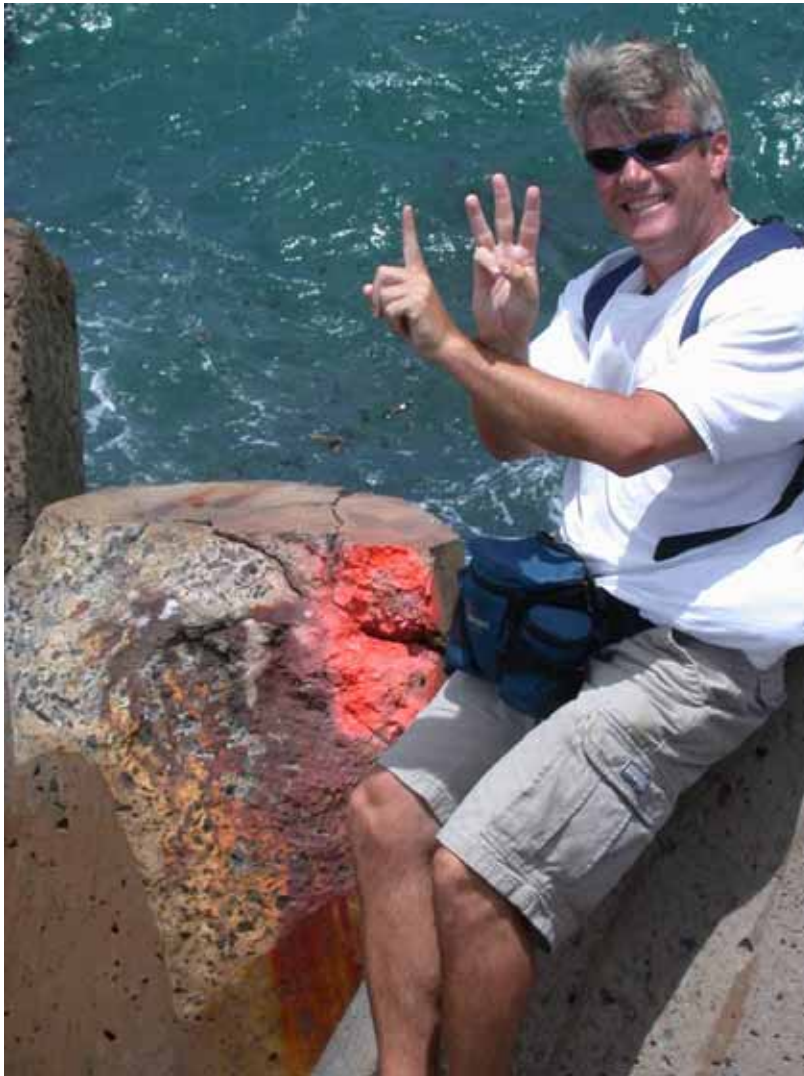
Figure B22. Damage location 27, sta 28+04, ocean side, rib #30, dolosse with tip chip.

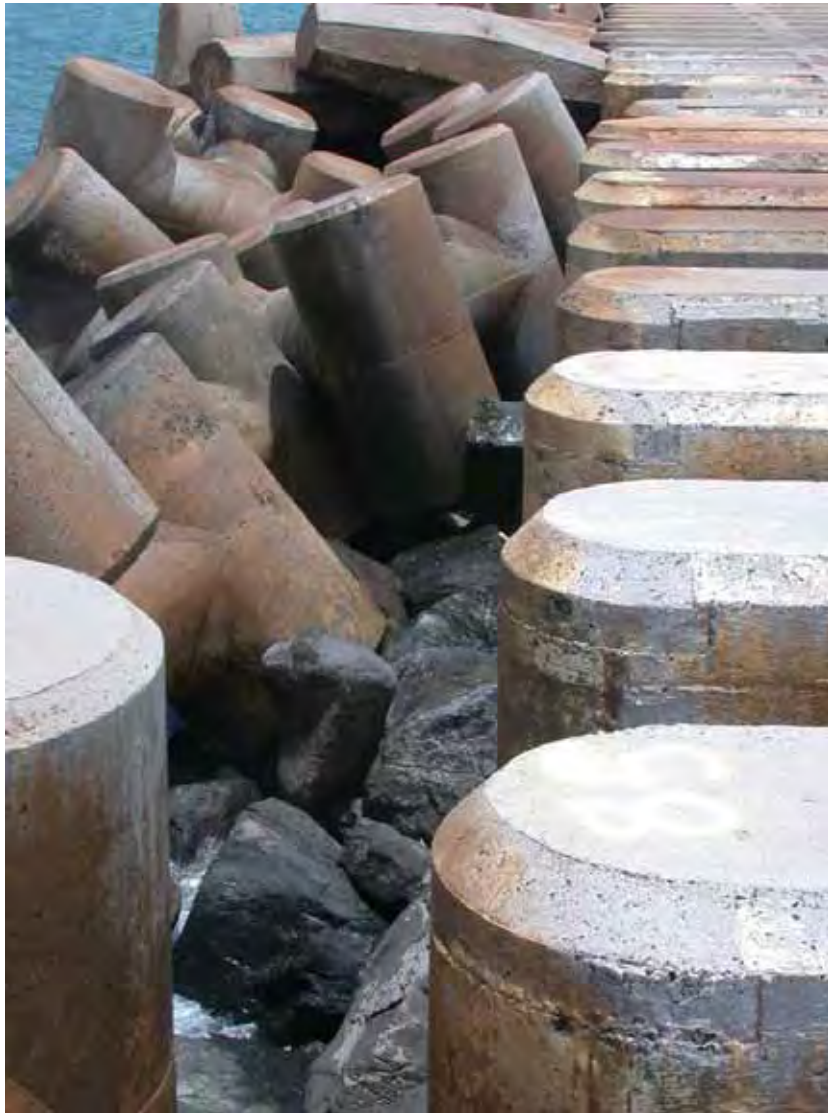
Figure B31. Damage location 40, sta 31+54 - 32+04, ocean side, rib #88 - 97, 8 ft separation of tribar from ribcap.

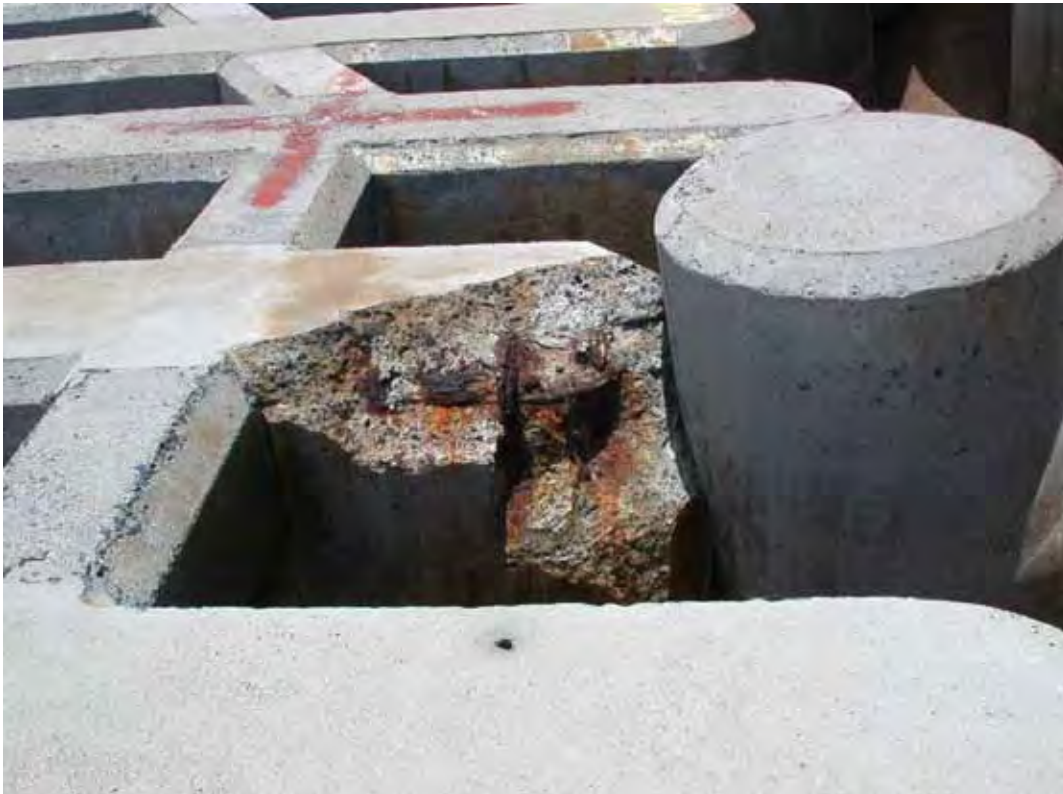
Figure B32. Damage location 42, sta 32+16, ocean side, rib #98, cracked and spalling rib cap, red cross painted on rib cap.

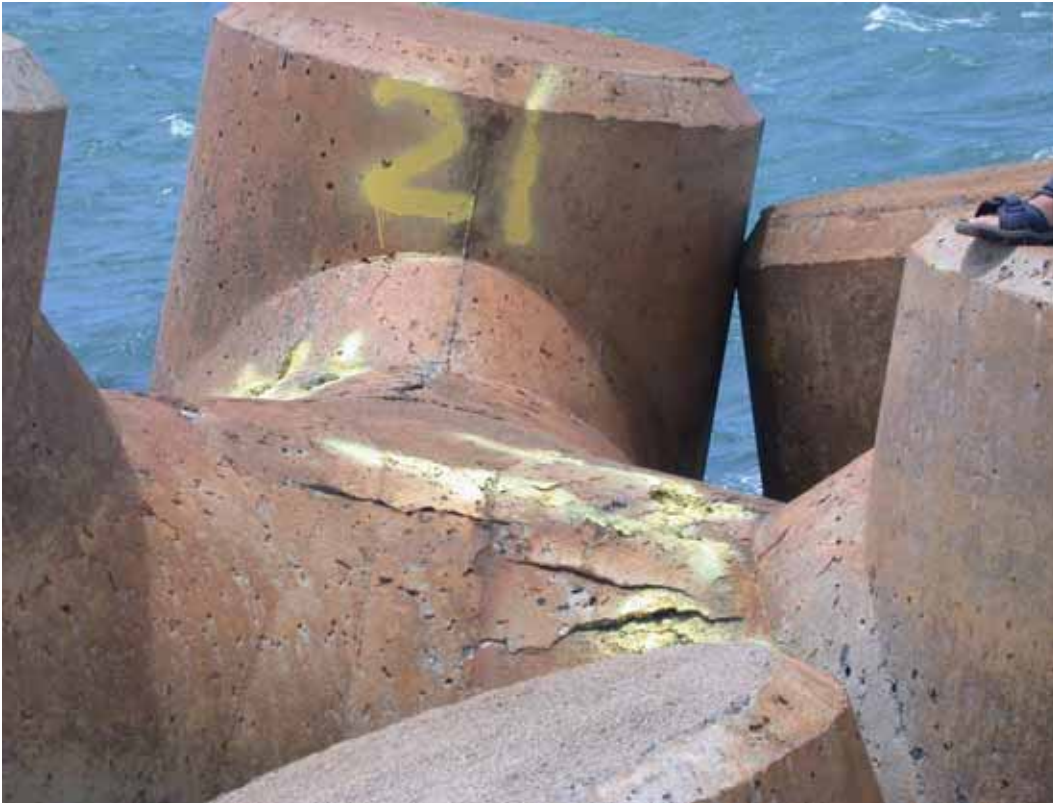
Figure B34. Damage location 45, sta 32+74, ocean side, rib #108, tribar with spalling.

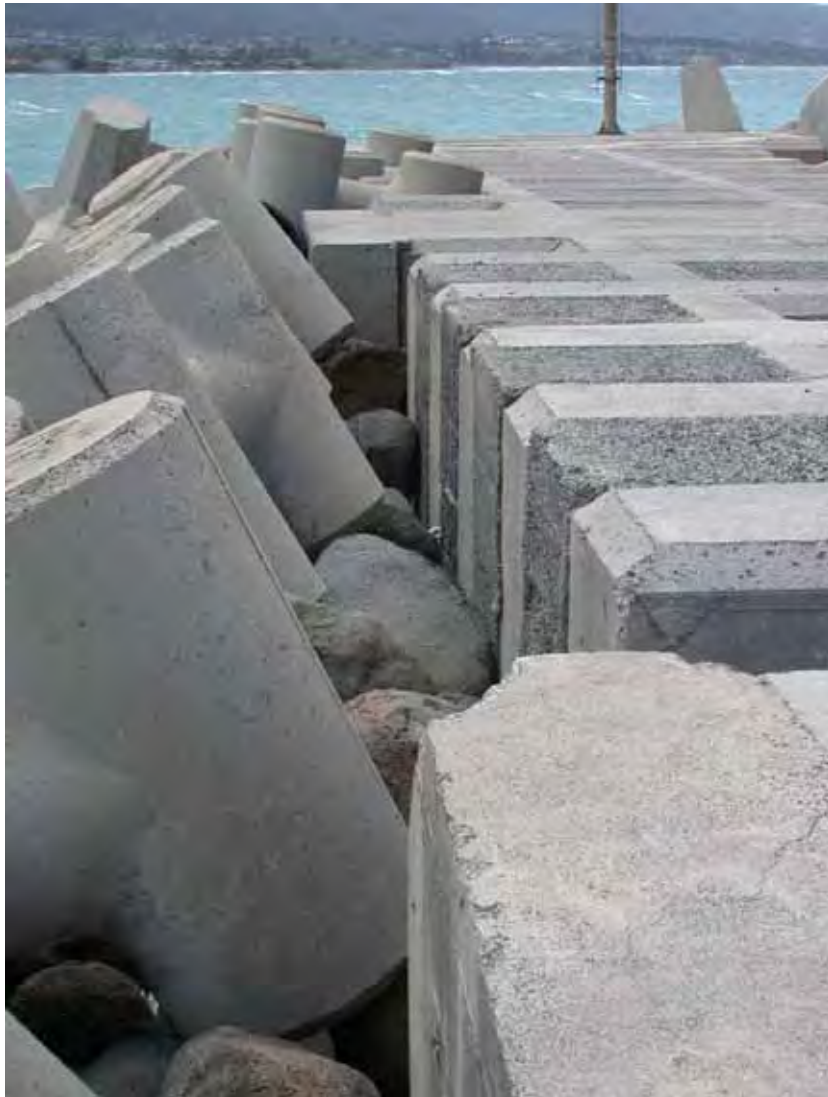
Figure B36. Damage location 48, sta 33+40 – 33+64, harbor side, rib #119 - 123, settling of tribar and separation from rib cap.

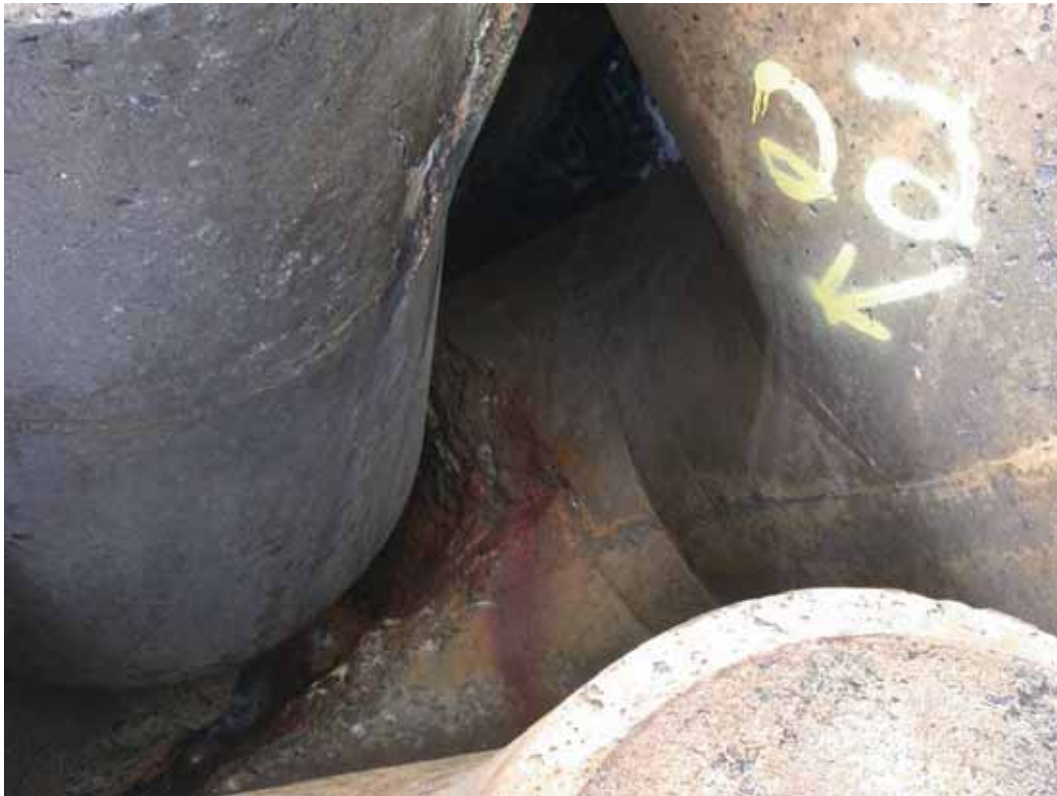
Figure B37. Damage location 50, sta 33+52, ocean side, rib #121, tribar with top of leg broken.

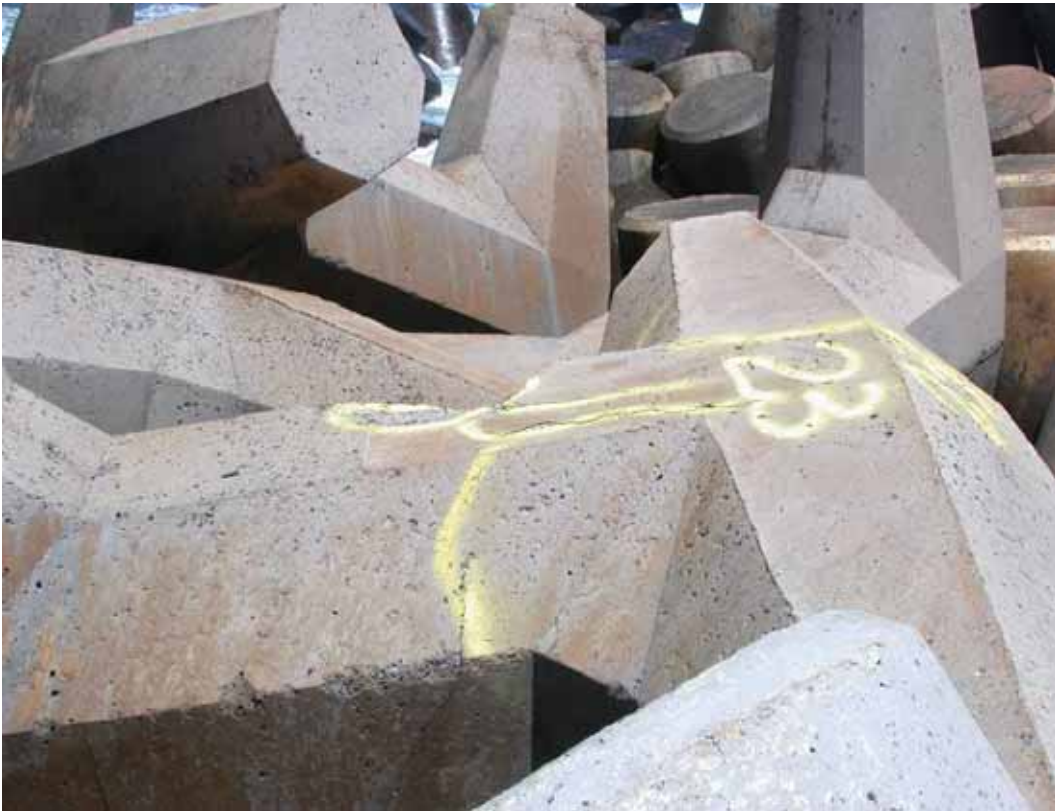
Figure B39. Damage location 54, sta 34+15, ocean side, rib #130, dolosse with crack through shank.

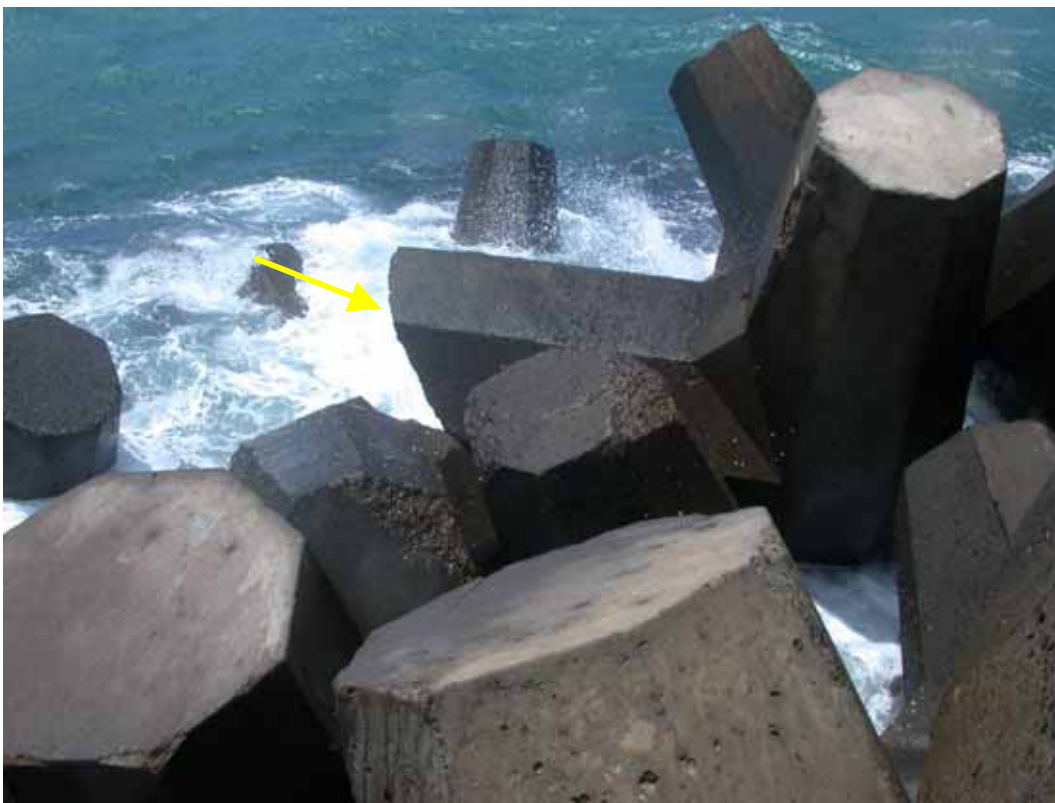
Figure B42. Damage location 57, head, 0 deg, dolosse with fluke break.

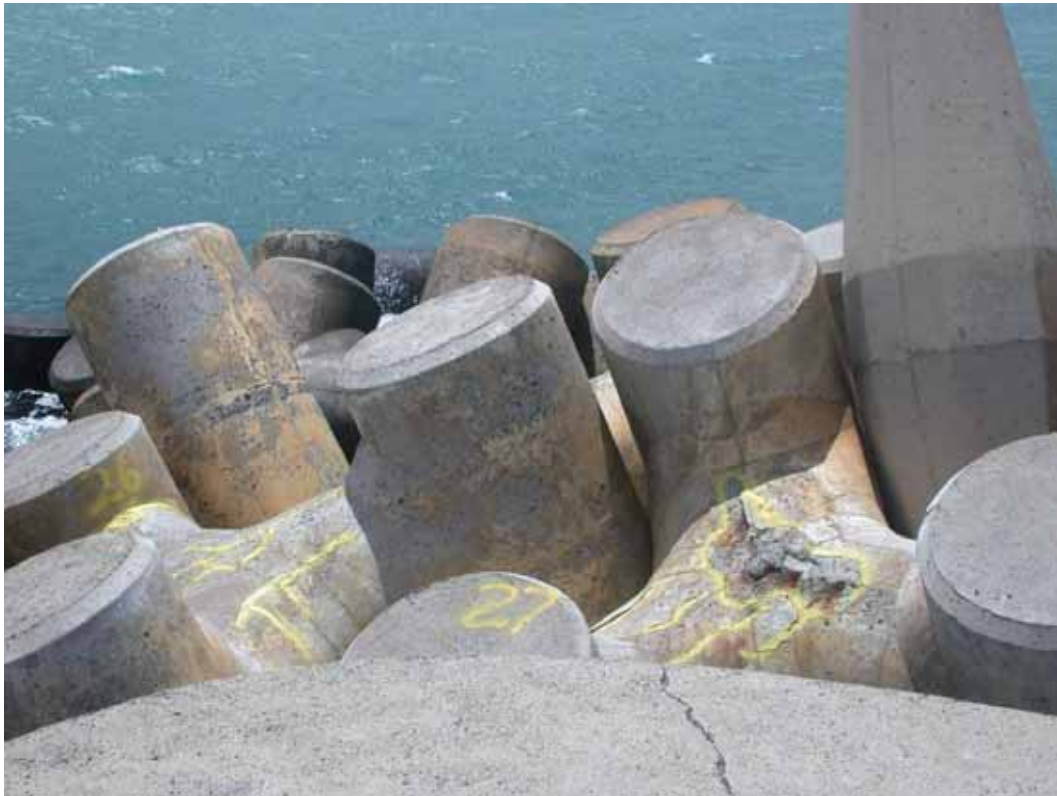
Figure B43. Damage location 58, harbor side of head, tribar with cracking and spalling.

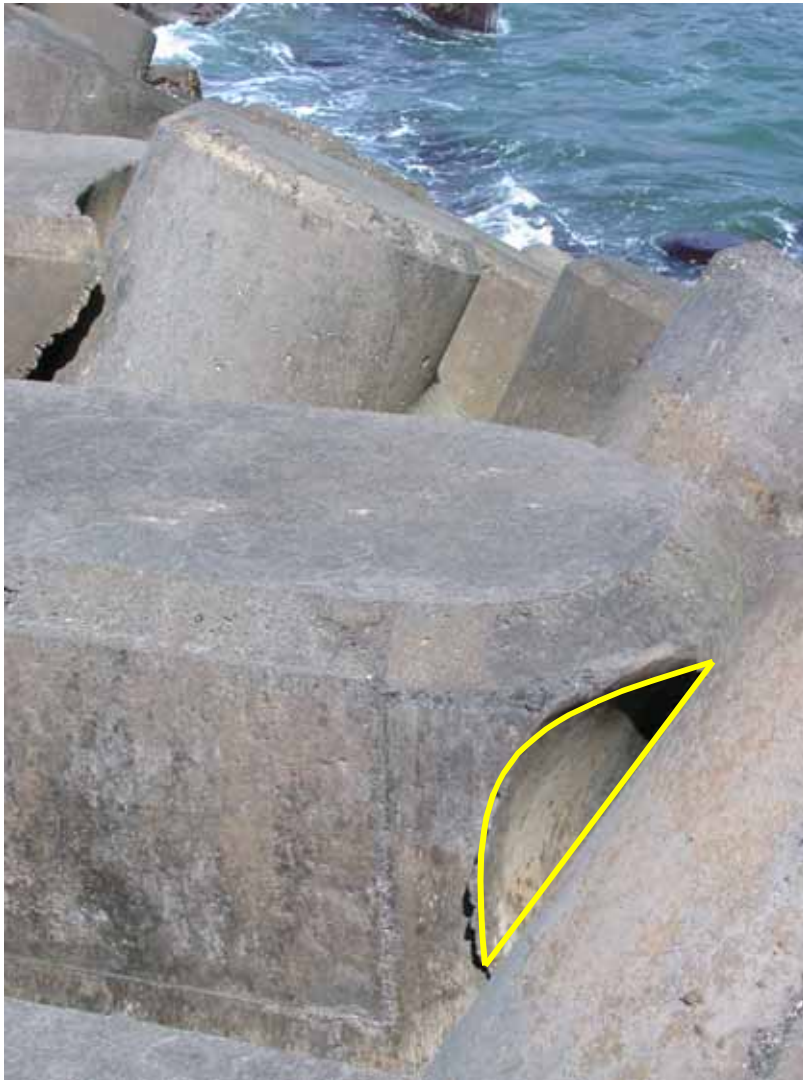
Figure B46. Damage location 3, sta 18+74, ocean side, rib #13, 8" separation of tribar from rib cap.

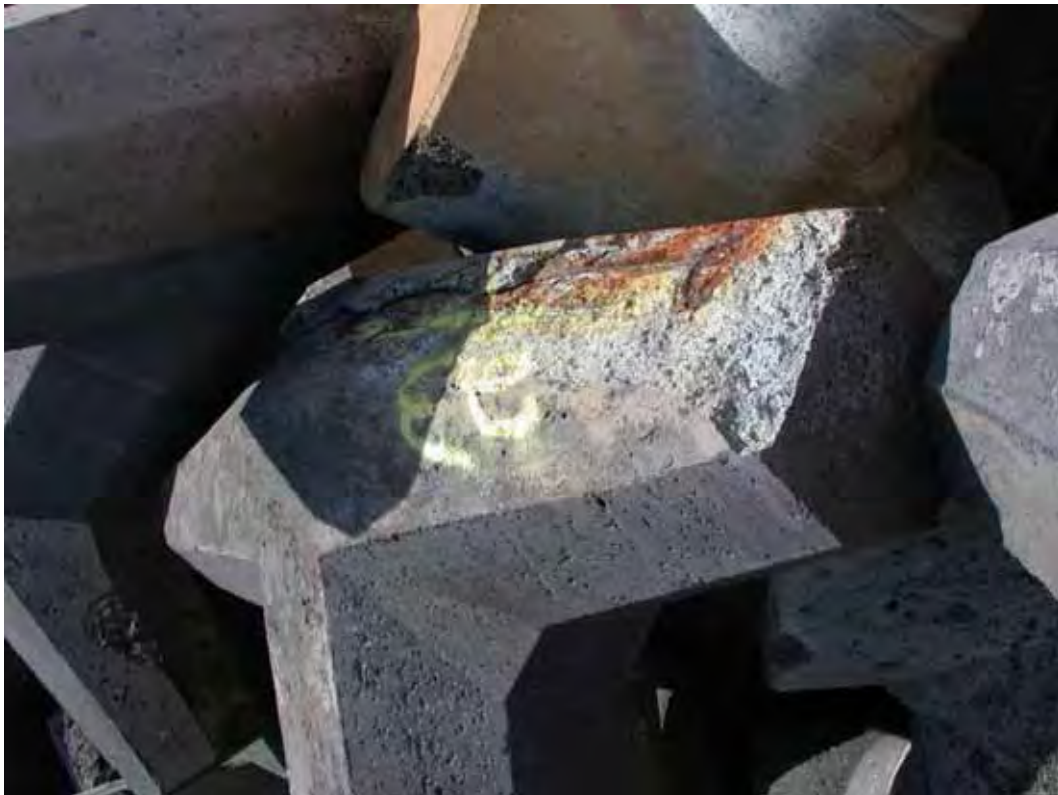
Figure B66. Damage location 29, sta 22+14, ocean side, dolosse with spalling.

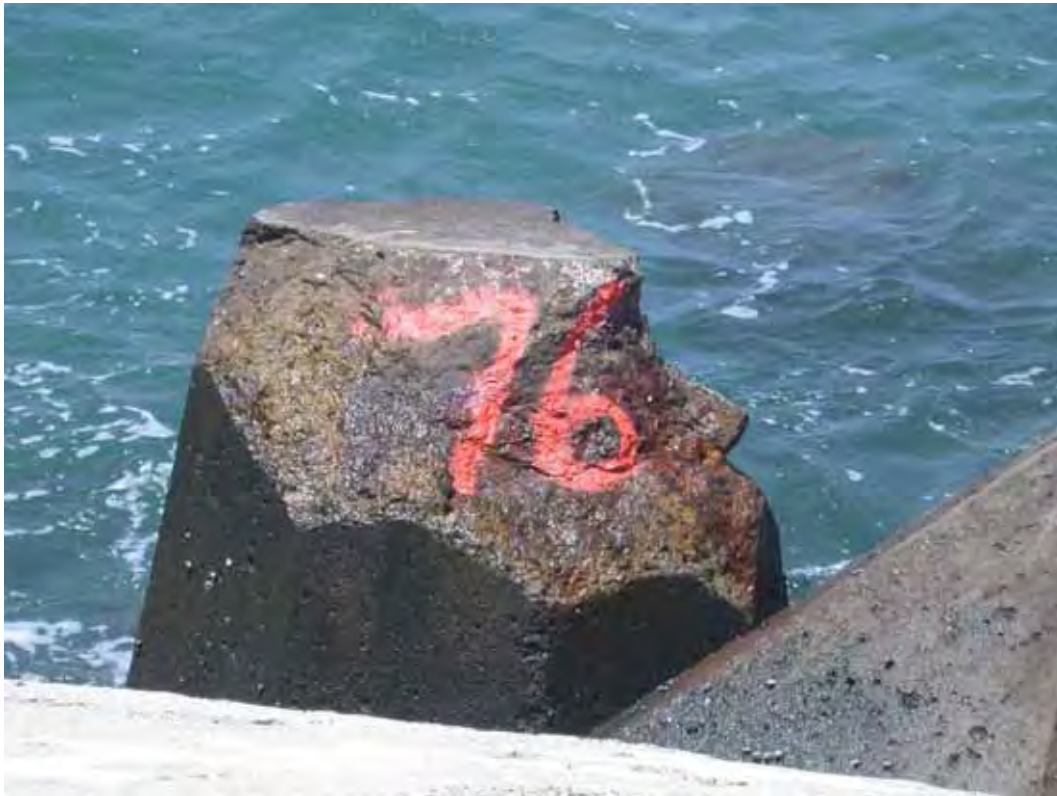
Figure B71. Damage location 36, sta 22+48, harbor side, dolosse with fluke tip break.

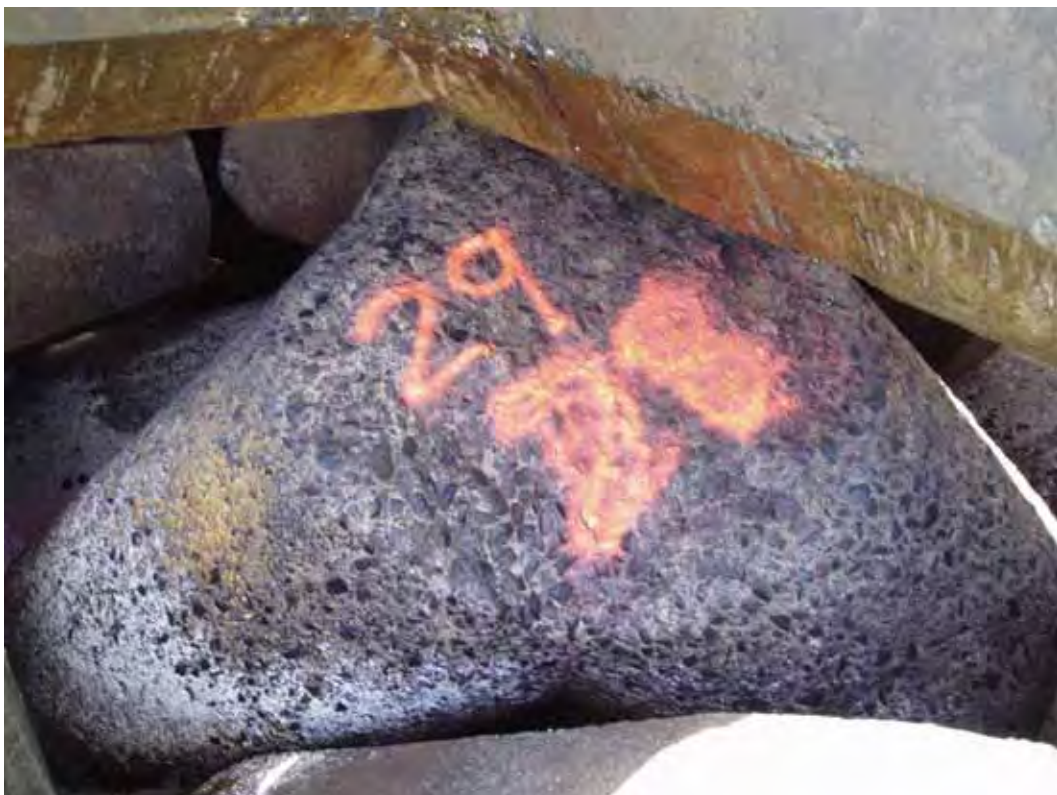
Figure B72. Damage location 37, sta 22+49, ocean side, tetrapod with broken top.

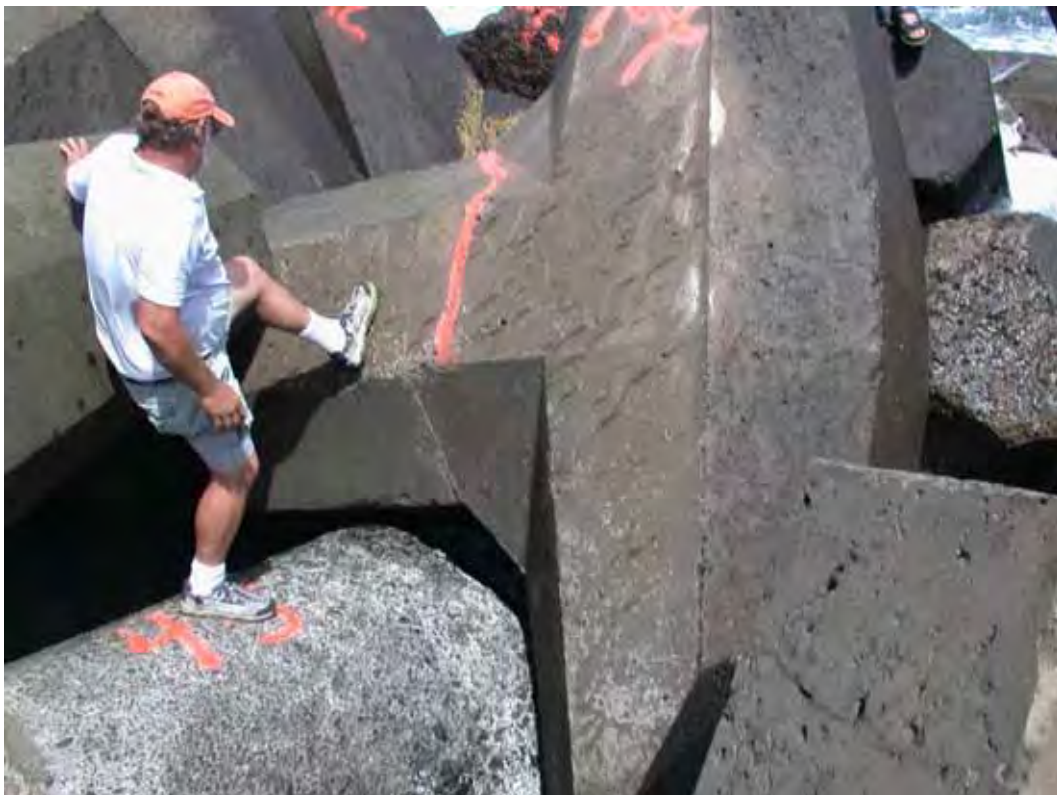
Figure B88. Damage location 58, sta 23+25, ocean side, dolosse with shank-fluke crack.

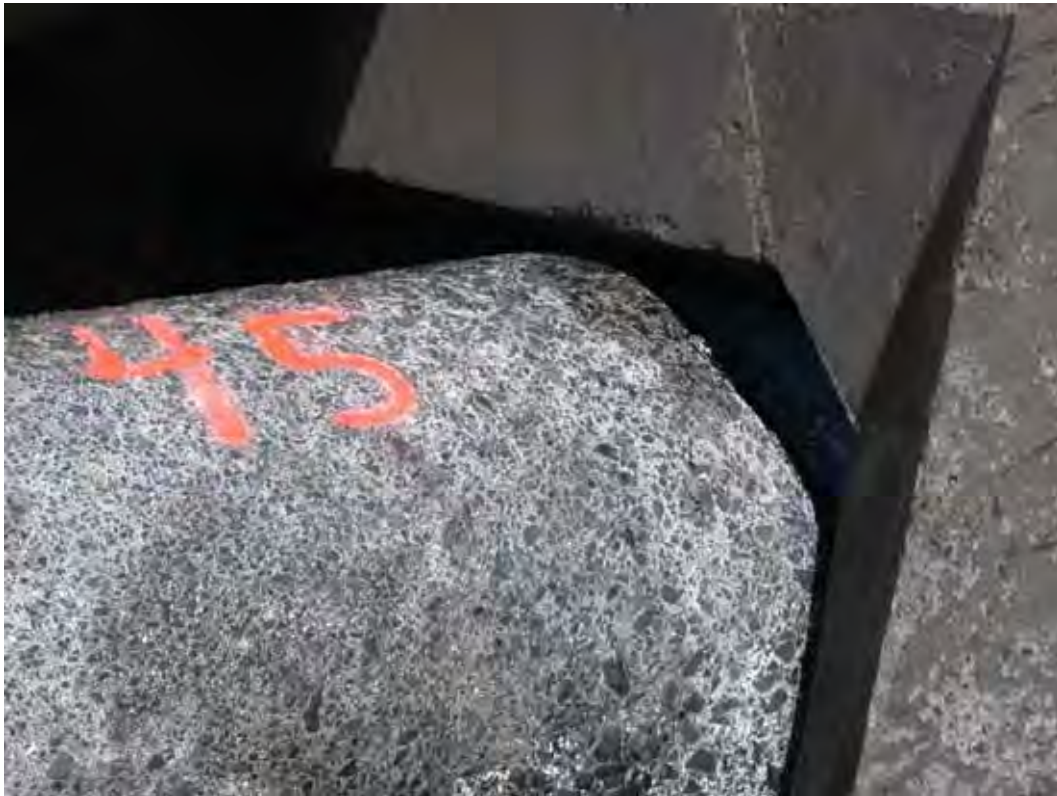
Figure B89. Damage location 59, sta 23+28, ocean side, tetrapod with missing top.

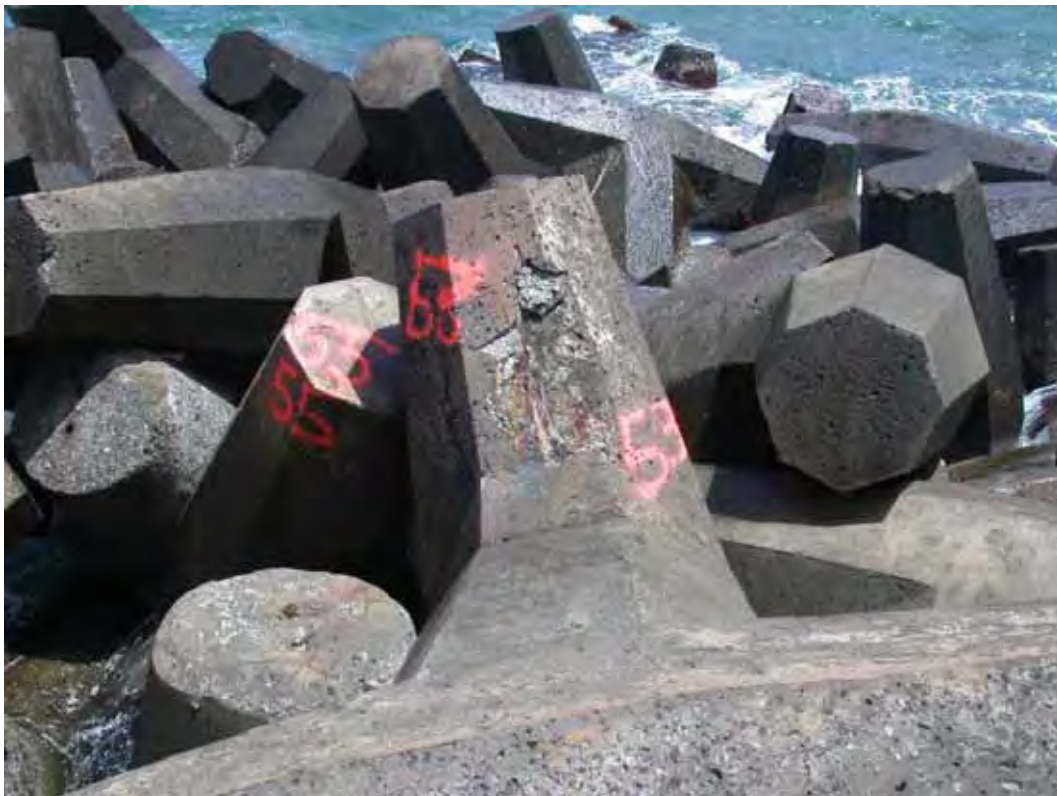
Figure B91. Damage location 67, 45 deg ocean side of head, dolosse with spalling.

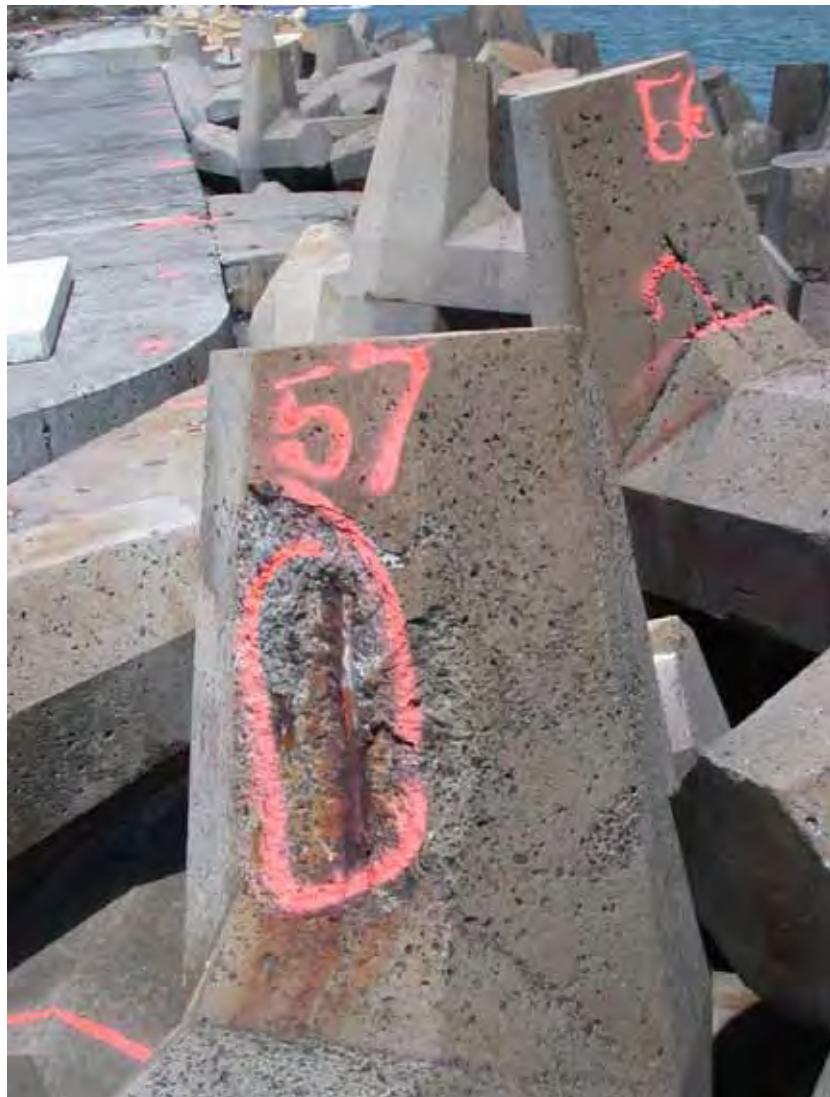
Figure B93. Damage location 71, 30 deg ocean side of head, dolosse with spalling and exposed rebar.

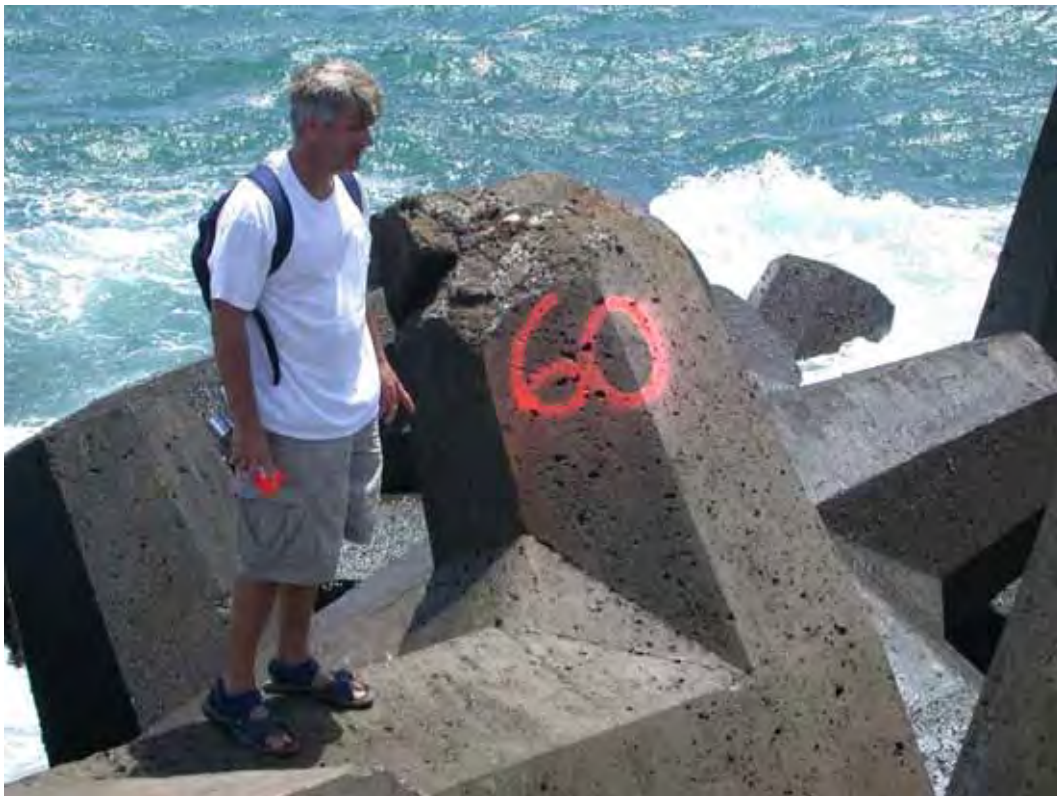
Figure B94. Damage location 72, 30 deg ocean side of head, dolosse with fluke tip chip.

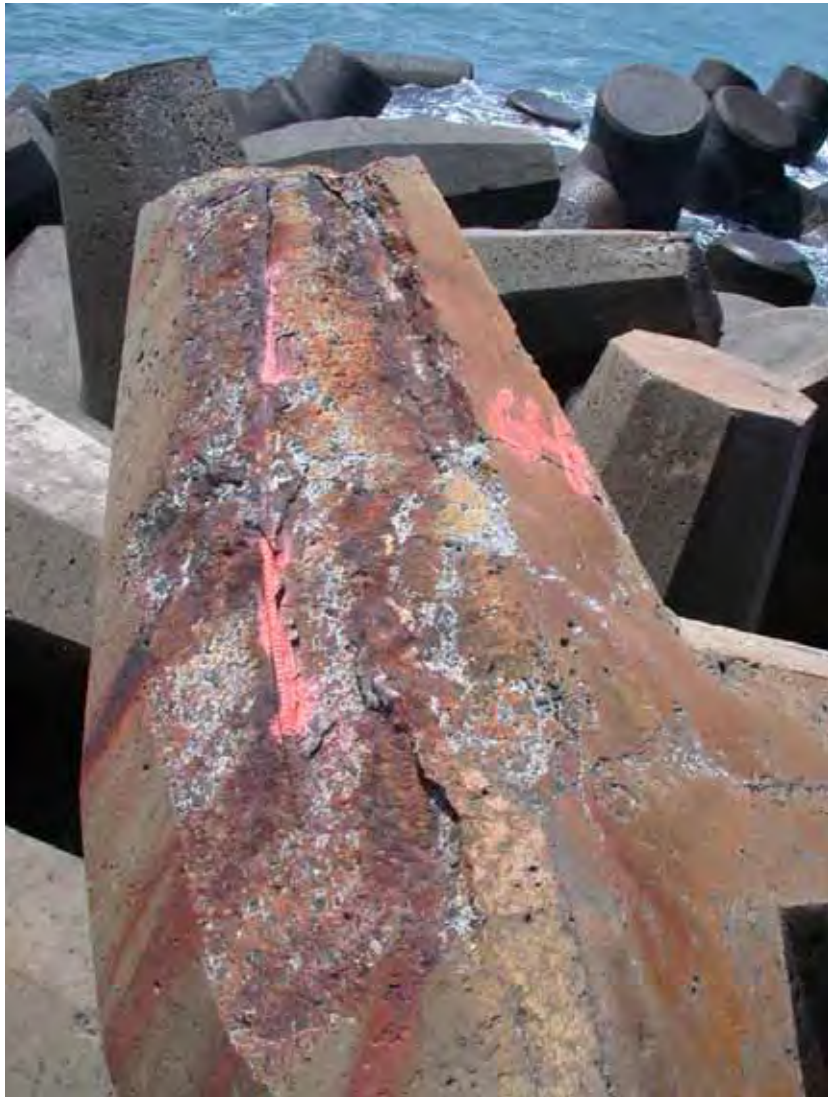
Figure B96. Damage location 78, 5 deg harbor side of head, dolosse with spalling, exposed rebar, and fracturing on fluke tip.

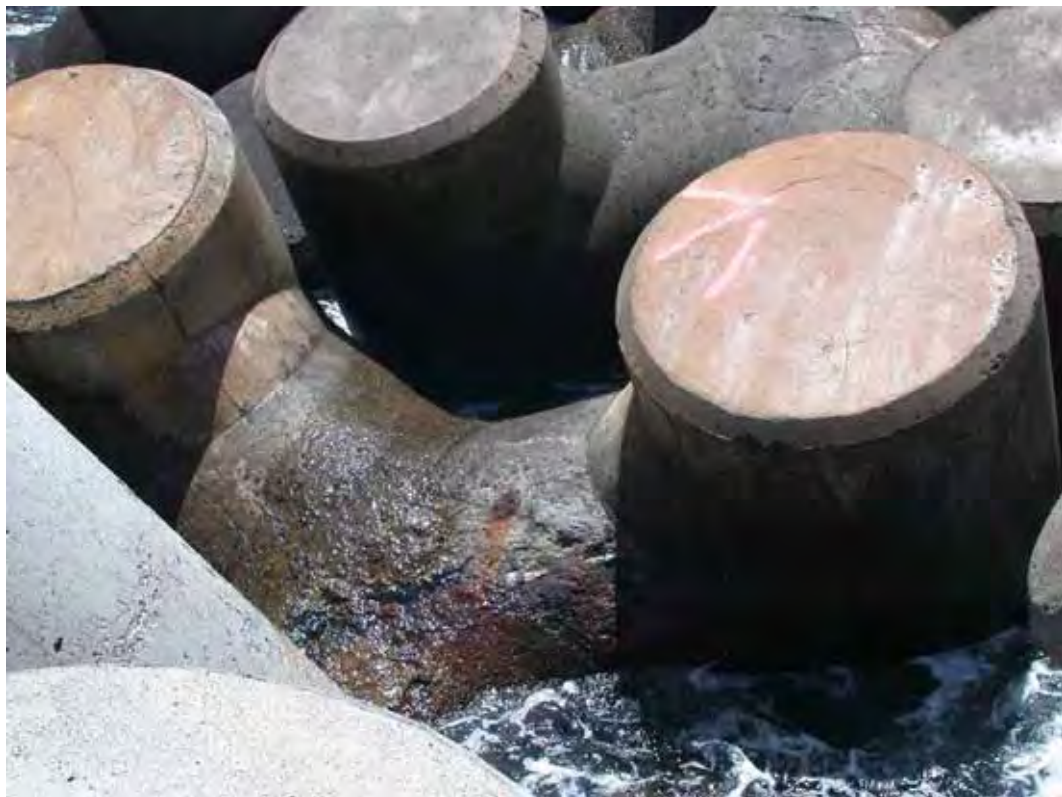
Figure B100. Damage location 85, 90 deg harbor side of head, tribar with spalling at center.

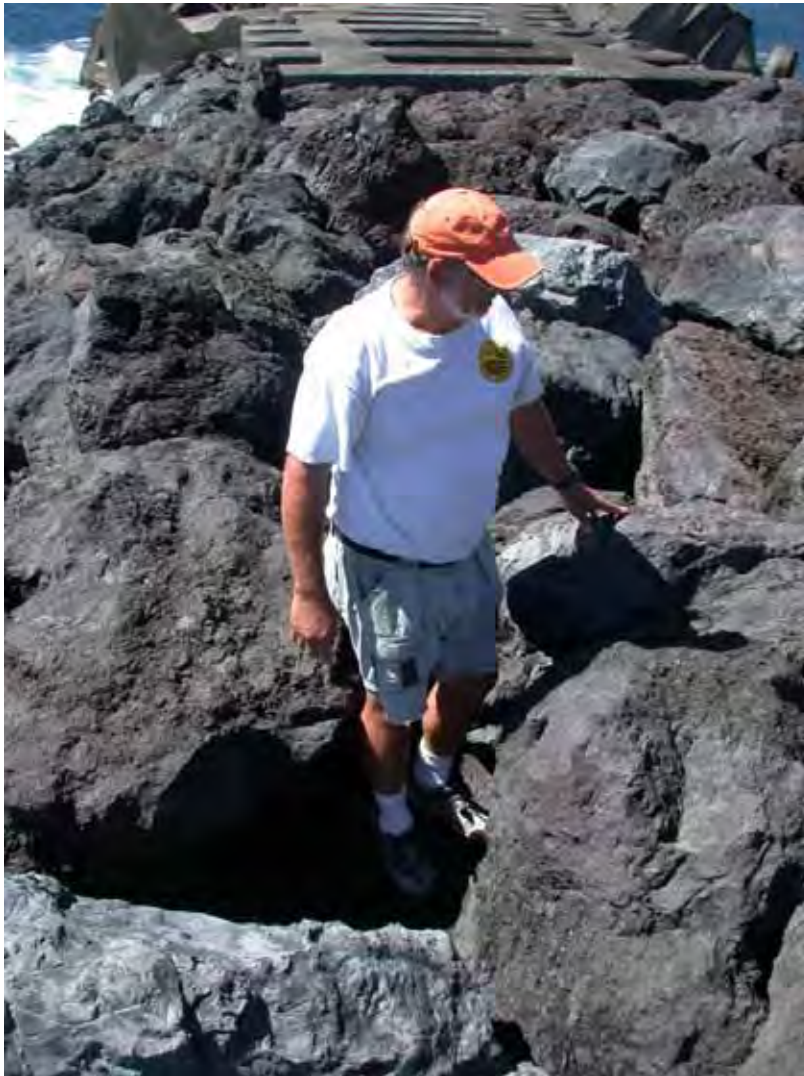
Figure C3. Void.

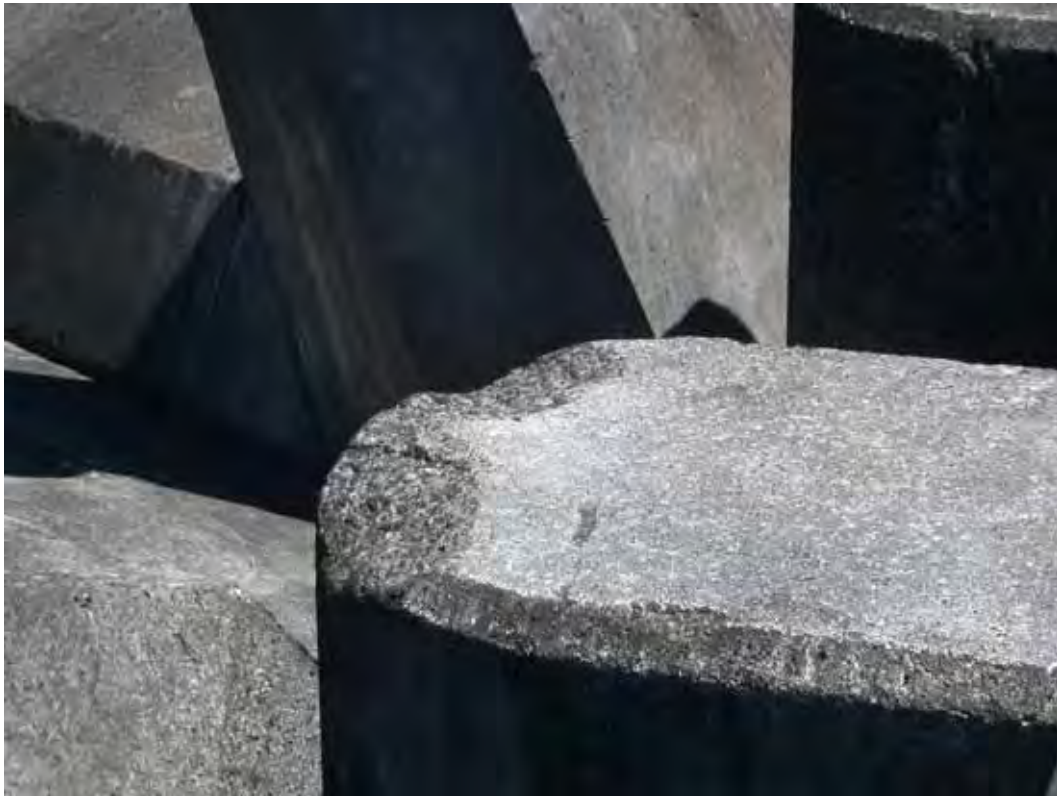
Figure C19. Rib damage possibly caused by displaced armor stones.

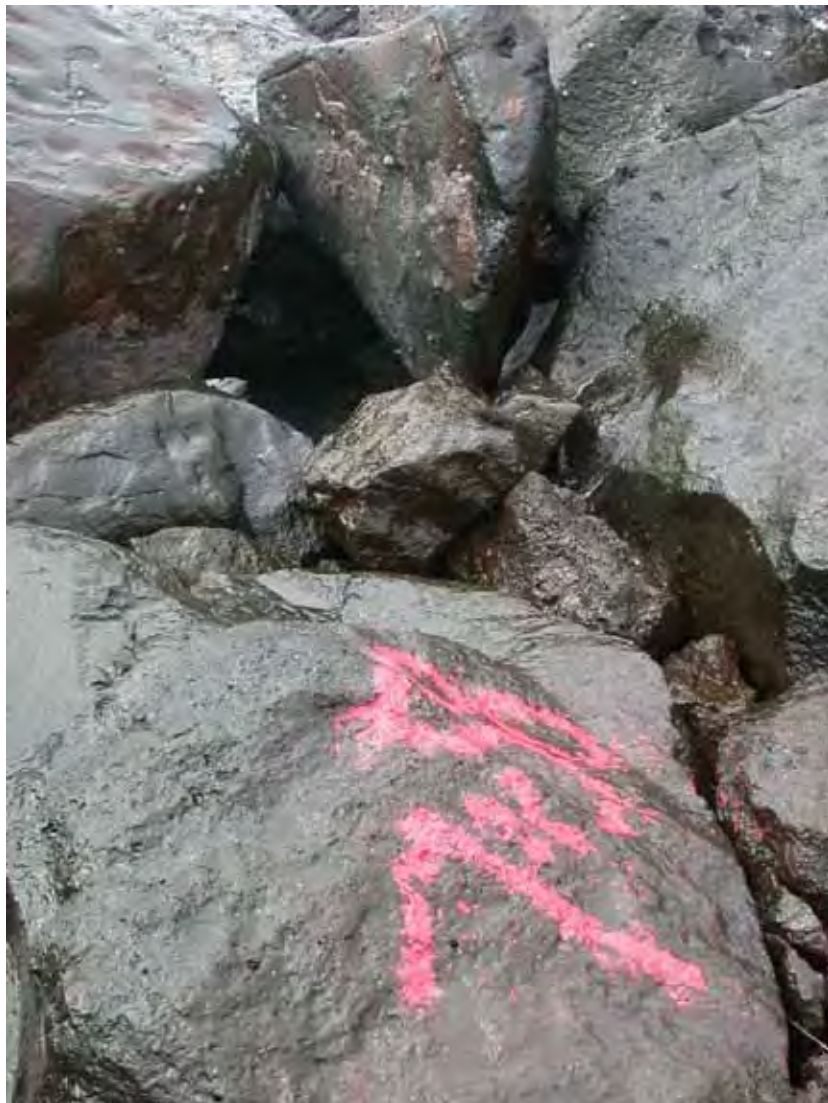
Figure D10. Damage location 9, sta 7+58, settling of crest.

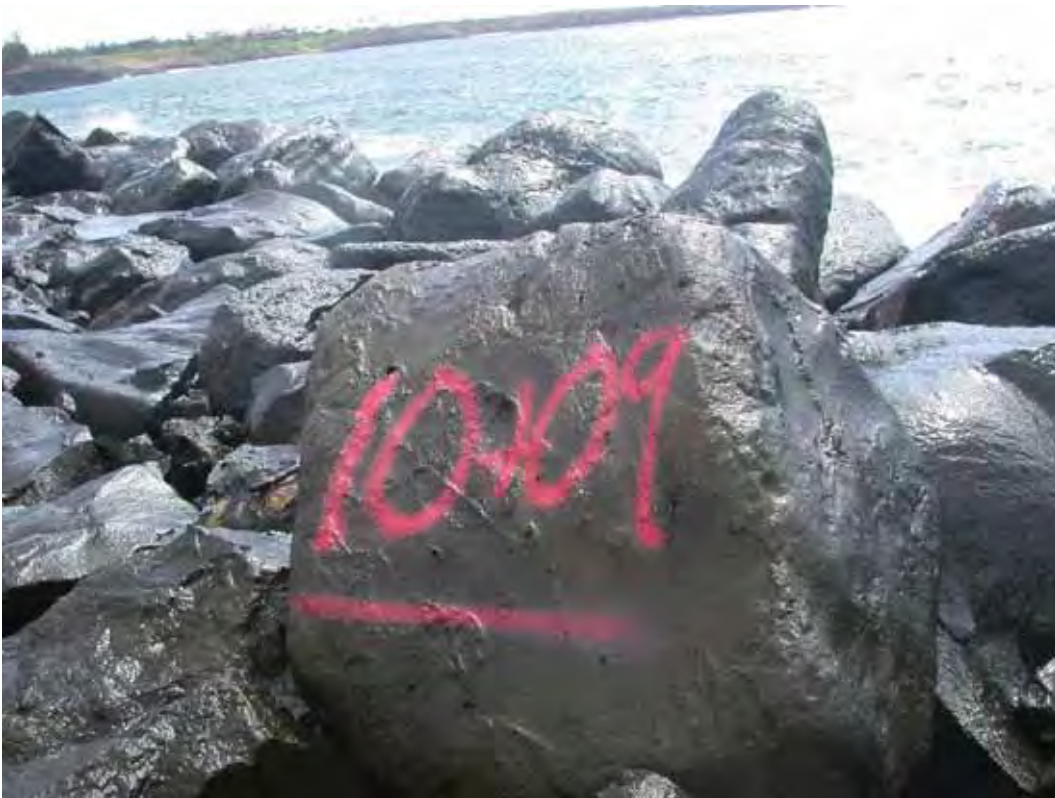
Figure D19. Damage location 18, sta 10+09, perched armor stone with void on crest.

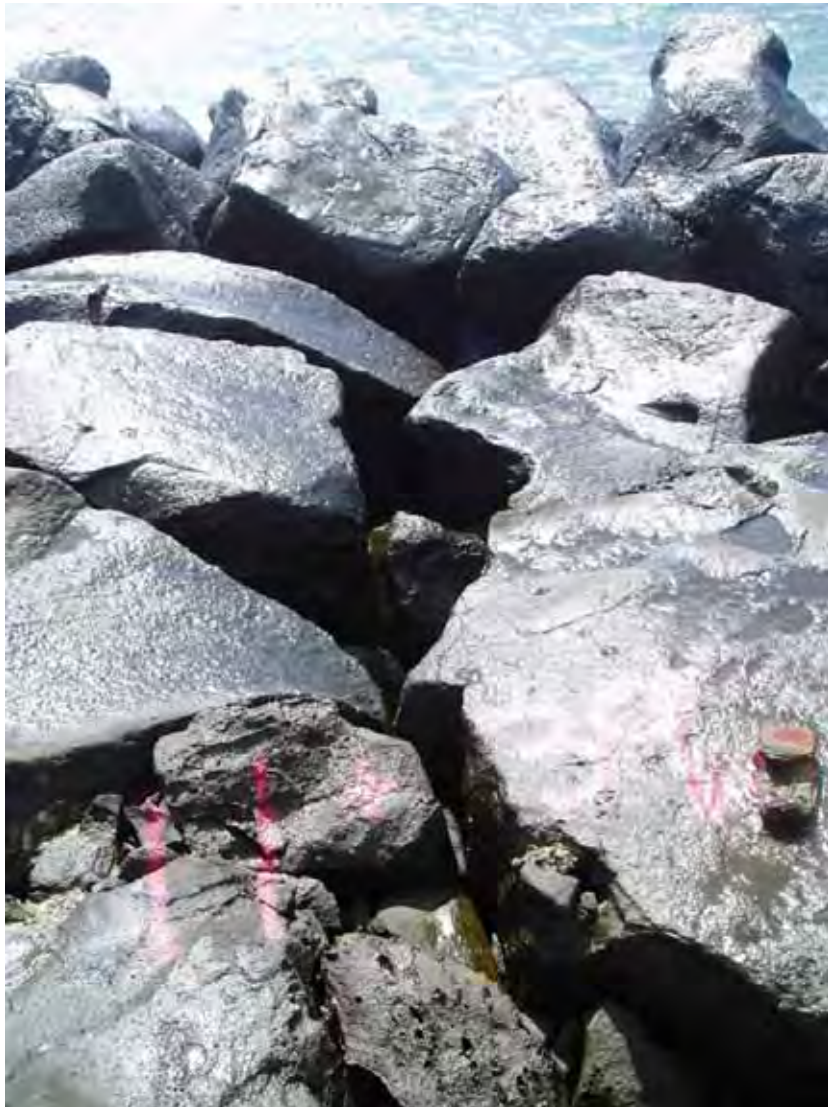
Figure D23. Damage location 25, sta 11+39, ocean side, depression/settling of crest, 5 ft x 4 ft void on crest.
